Simon Pryce Arboriculture

Site: Tooting Bec Lido, Tooting Bec Road, London, SW16 1RU

Subject: Constraints report and arboricultural impact assessment

Reference: 23/001

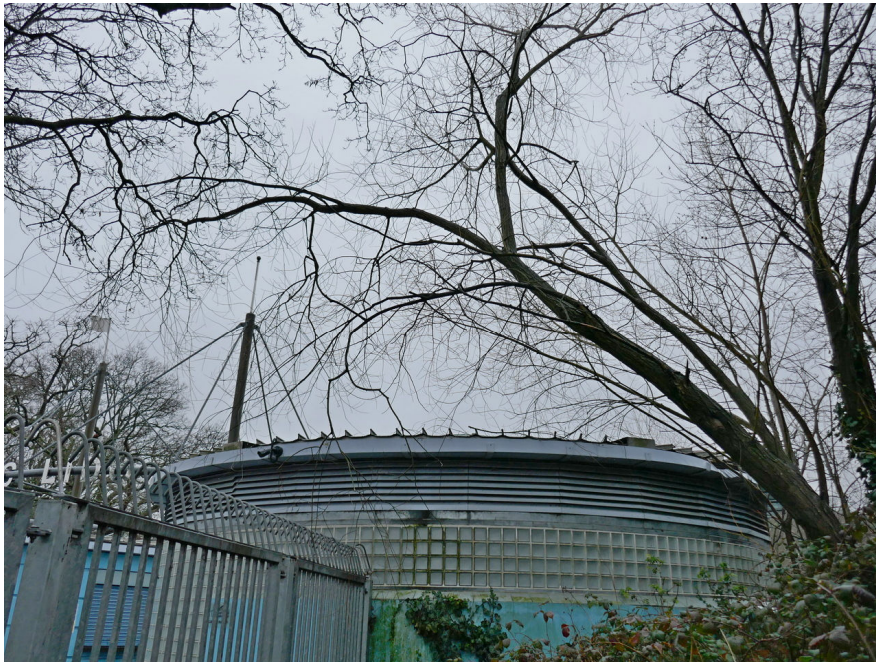
- 5.1 The ash proposed for removal, tree 7, is shown in photo 2 below and is a poor quality tree with no potential to improve and would need to be removed in the foreseeable future, irrespective of any building work. Tree 3 is in photo 1 and was not listed for removal but has a severe lean over the roof of the existing changing room. It has already damaged the edge of the roof and would hang lower when in leaf, so it also needs to be removed.
- 5.2 Tree 1, an ash, is some distance from the work area so is not directly affected, but has severe decay in the upper crown, shown in photo 3. The fungus found beneath it was *Inonotus hispidus*, which grows on a range of broadleaved trees. In ash it causes severe weakening in the early stages, so trees can fail suddenly. This tree is close to the boundary with the common, so it needs to be removed for safety irrespective of the proposal.

1) Tree 3 showing acute lean and damaged edge of the roof

3	Crack willow	MA/N	12	11	0	3	3	220	2.7	22	3	Exceptionally heavy lean over the building due partly to shade from other trees but stability is suspect. <ul style="list-style-type: none"> • <i>Fell - stump could be left to sprout but would need frequent recutting and would be better removed or treated to prevent regrowth.</i> 	U
4	Goat willow	MA/N	12	4	5	5	4	250	3.0	29	3	Drawn up due to growing among the other trees, otherwise sound and healthy.	C
5	Various	Y/N	5 - 7	1 - 3				30 - 100	1.2	4.5	1 - 2	Group of self-seeded ash and sycamore saplings and sucker shoots growing from the roots of the willows. Generally healthy and will grow on to compensate for the removal of the others.	C
6 *	Oak	M/N	23	12	13	12	12	1080	13	530	5	Very large tree, twig growth is slightly sparse, but it is sound and healthy looking.	A
7	Ash	MA/L	16	7	5	5	7	320 120	4.1	52	6	One sided and leans due to growing under the oak, has a large wound on the trunk that is occluding, but also has signs of die back in the top. <ul style="list-style-type: none"> • <i>No urgent work needed, but not suitable for long term retention.</i> 	U

- 6.1 The proposal requires the removal of tree 7, a poor quality ash with no potential to improve.
- 6.2 Tree 1, also an ash, is not a constraint, but has severe decay and needs to be removed for safety in any event, as does tree 3, a heavily leaning willow that has damaged the roof.
- 6.3 The RPA circles of trees 4, 6 and 8 are partly under the new footprint, but that largely coincides with the existing footprint where few, if any roots will be present. The areas concerned are small and well within what these trees will tolerate, particularly as they have good rooting conditions in other directions.
- 6.4 Access will be needed onto some of the soft ground in RPAs, but the trees can be safeguarded during the work by a combination of fencing and ground protection as shown on the tree protection plan.

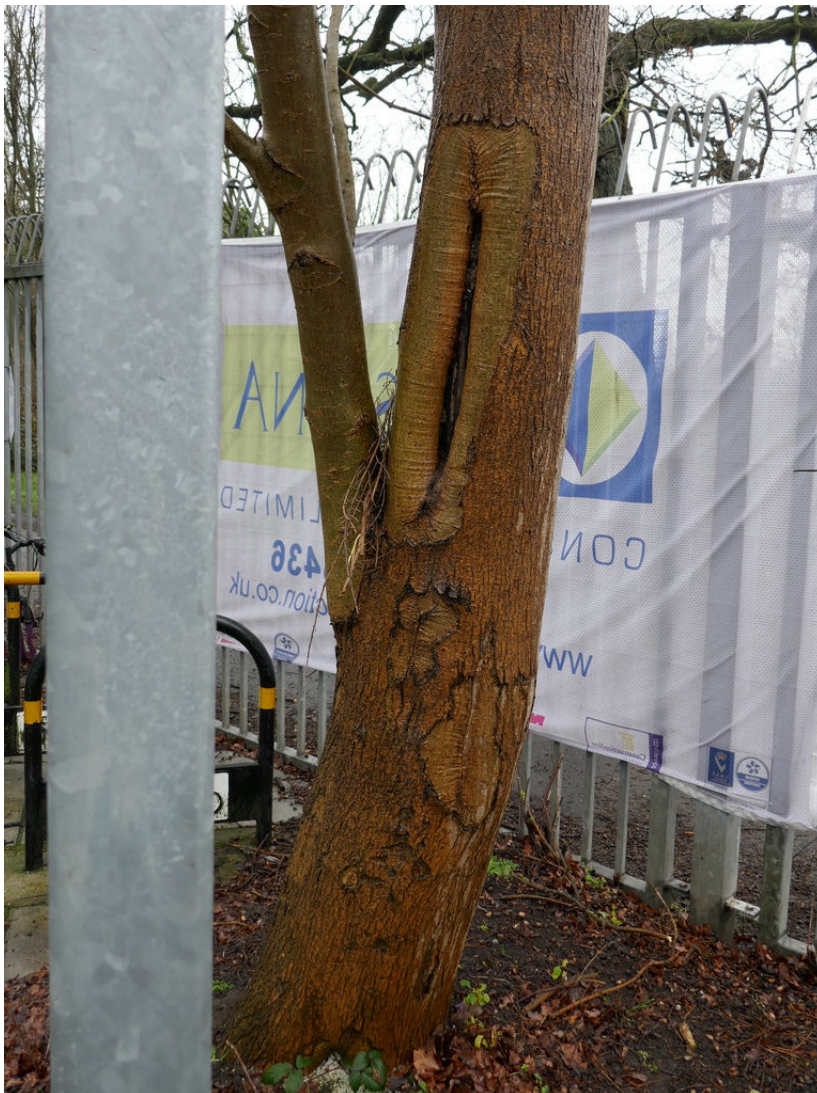
- 3.2 Most of the other trees surveyed are on the bank to the south of the entrance and include some self-seeded sycamore and willows and a mature ash with significant structural decay. The ash proposed for removal is just inside the security fence, has a large wound on the trunk and is being suppressed due to growing under the large oak on the common.

2) Wound in the trunk of tree 7. View is directly along the fence, showing proximity to it.

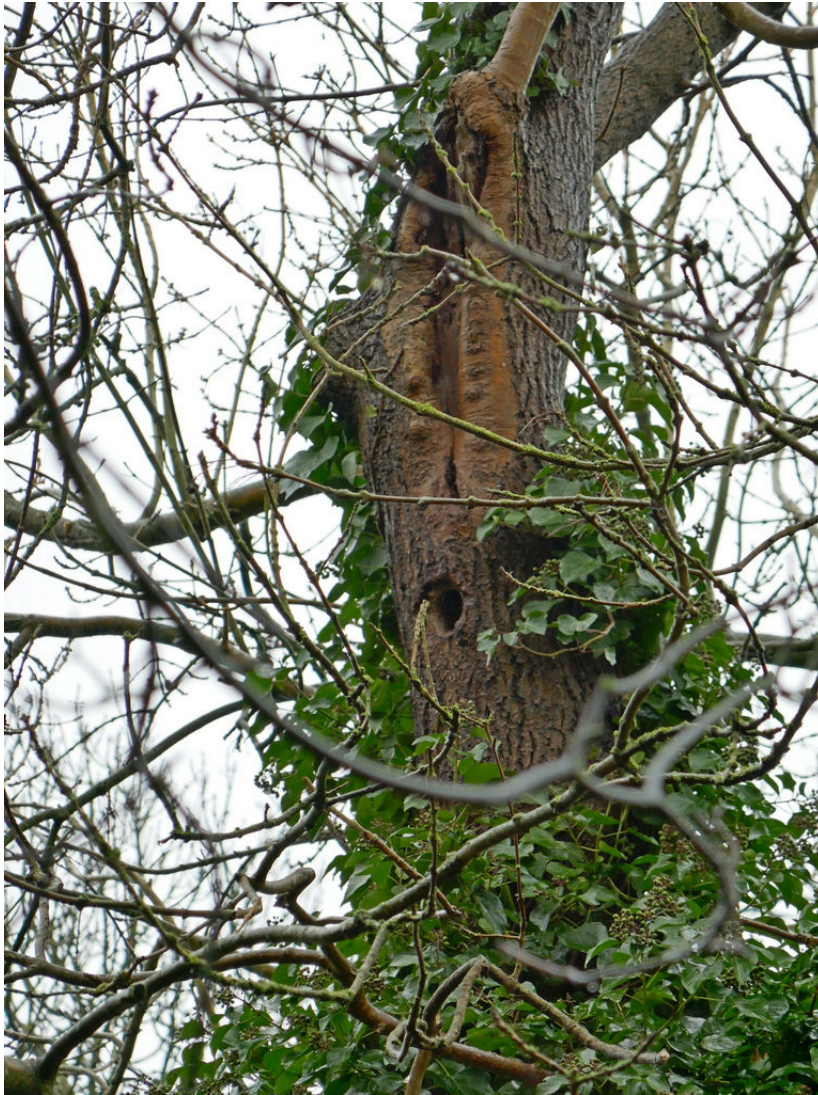
3) Large old wound and woodpecker hole in the top of tree I. Not affected by the proposal but needs to go.
