TOOTING LIDO CHANGING ROOMS,
TOOTING BEC LIDO,
TOOTING BEC ROAD,
TOOTING COMMONS SW16 1RU.

June 2022

Job Title. Preliminary Bat Habitat Assessment changing rooms and reception building
Tooting Bec Lido

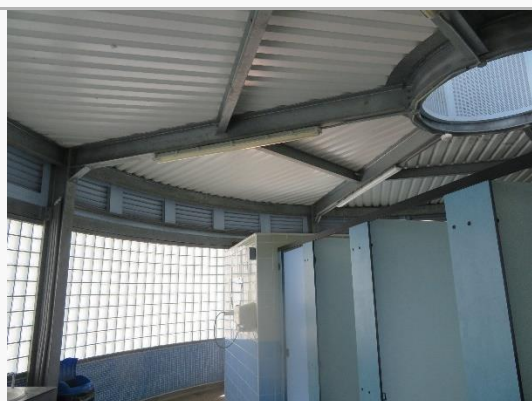
3.2 The internal inspection found a total lack of evidence of animal ingress. There were no internal voids in either changing room. The male changing room was not entered. The reception building was occupied by staff and not entered.

Photo 1: Female changing rooms, no roof void.

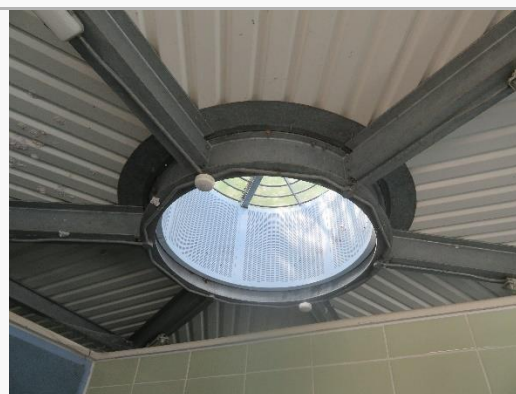
Photo 2: Good view of the roof material and vent.

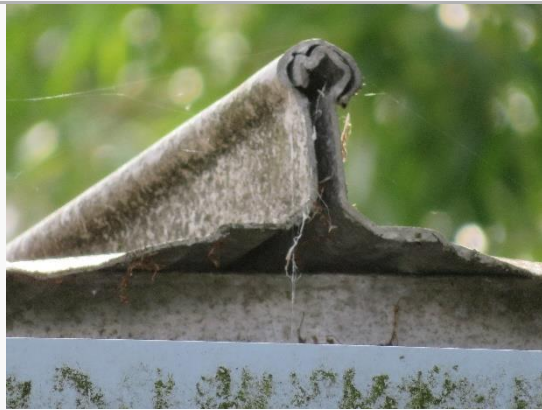
Photo 3: Corrugated sheeting: the pleats or folds form accessible voids

- 3.5 All three roofs were similarly constructed. This means they had corrugated roof sheeting with pleats at the roofline, which formed a gap or void. Beneath this was a large soffit box around the changing rooms. This was investigated for animal droppings, although none were found.

- 4.2 It must be stated that there were gaps in the pleats within the corrugated sheets, but these were not optimised for bats. That is not to say that bats do not use steel buildings, as they frequently roost in expansion joints in steel framed buildings, but only where the temperature fluctuations would be minimal. This roof would be greater than a living organism could bear in the midday sun.

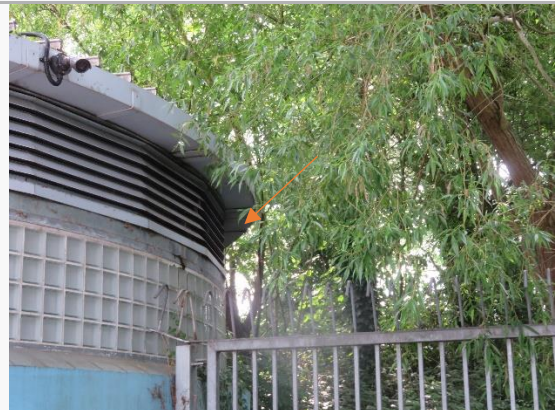
Photo 4: The female changing rooms in proximity to the vegetation, exhibited an area of soffit (marked by the arrow) that could not be closely investigated.

- 3.6 The female changing rooms were not entirely visible on the south side and there was a close connection with the south side and the woodland Photo 4.

- 4.3 The soffit around the female changing rooms requires additional comment. This could not be seen satisfactorily using binoculars; it was not possible to climb up to the area for a more complete view.

Table 4	
Area of works	Summary Mitigation
Soffit box female changing rooms	<p>Soft stripping of the soffit on the female changing rooms should be implemented. This is because the southern side could not be viewed during the inspection and the Desk Study returns.</p> <p>If droppings (see below) are found in any areas, then work must be halted and advice sought to acquire a European Protected Species licence.</p>
Bat droppings
