BAT HABITAT ASSESSMENT SURVEY REPORT,
BALHAM BOXING CLUB,
CAVENDISH ROAD,
BALHAM, SW12 0PP.

March, 2019

Job Title. Bat habitat assessment report, Balham Boxing Club, SW12 OPP

Purpose Planning application for floodlighting for external use

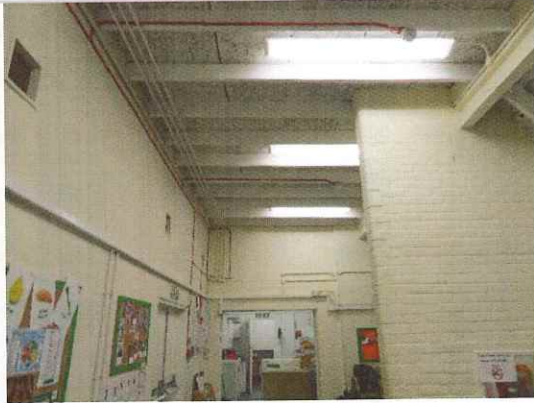
3.8 The internal inspection found a long, narrow building, which was largely open plan with roof rafters exposed. The roof was boarded with a type of fibreboard onto which bitumen felt was placed. There were gaps between the internal blockwork partitions and the fibreboard, but the rest was sealed.

Photograph 1. Underside of roof in the centre

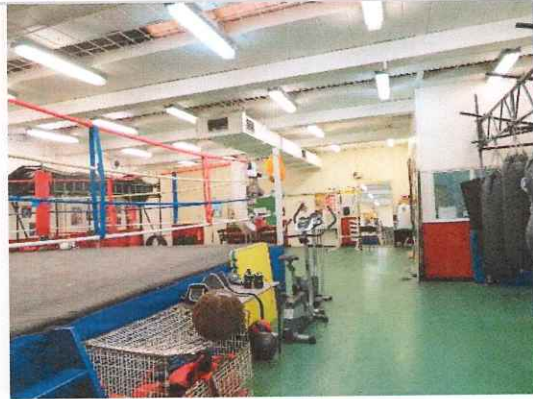
3.12 The Boxing ring is in a rectangular metal 'box' with a sophisticated ventilation system with a boiler room and gas flue at the western end. It is extremely well lit and has small storage rooms and office space that were entered.

Photograph 2. Boxing ring

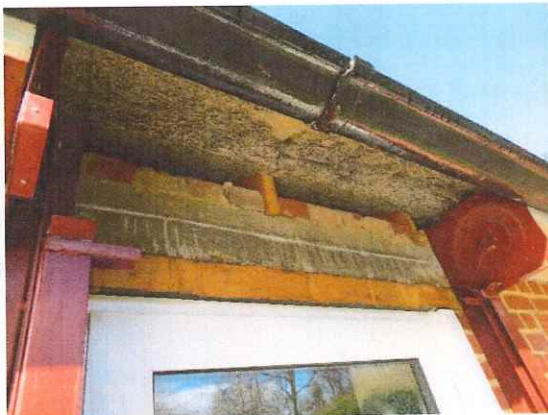
3.6 Above the door into the garden there was damage to metal security shuttering which exposed the eaves into the roof. A gap above the door lintel was also apparent and immediately adjacent was

Photograph 3. Missing metal canopy with gap at eaves above door

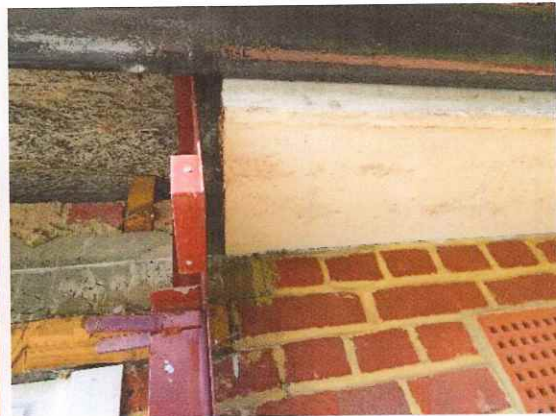
a gap in the soffit formerly used to accommodate the metal shutter. This was the only gap in the soffit and the building was determined as of low potential for bat interest.

Photograph 4. Gap at soffit (area adjacent to photo 3)
