# Wandsworth Common Management and Maintenance Plan

Volume 1: Understanding Wandsworth Common

Prepared by LUC in association CFP, Bosky Trees, SYSTRA and Rees Bolter Architects

October 2019

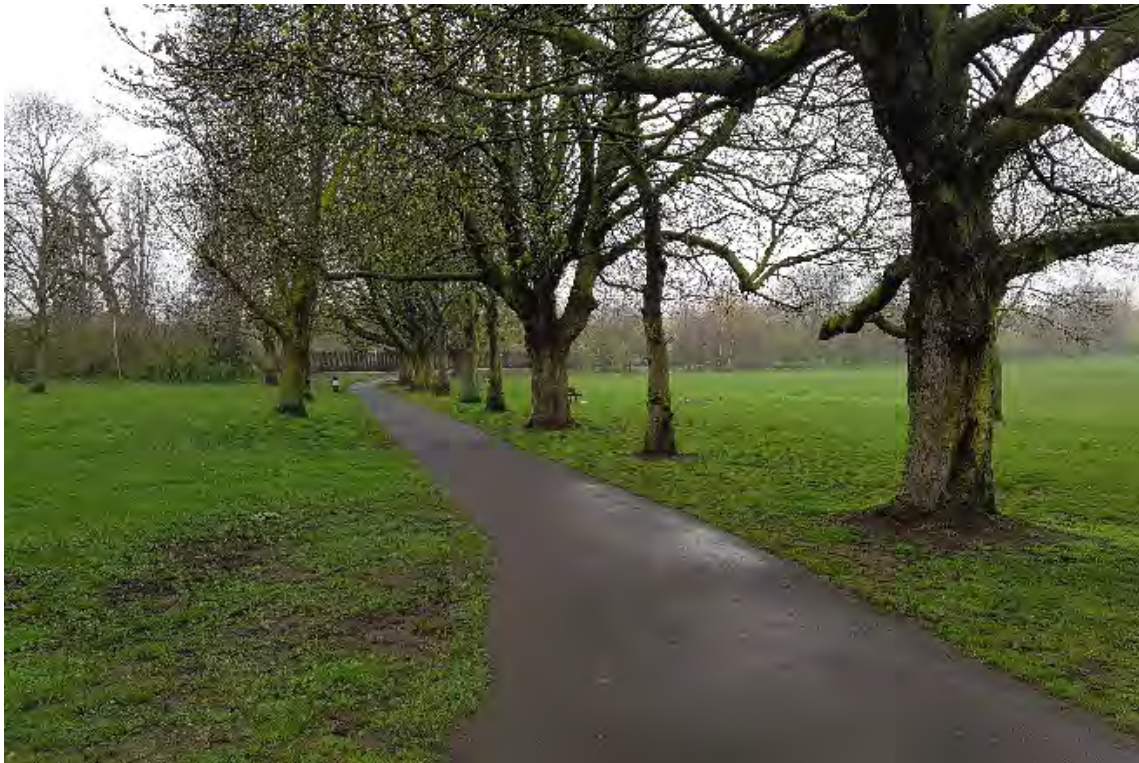
Figure 5.3 Avenue 3, Wandsworth Common, April 2018

- 5.14 Avenue 3 is situated within Bolingbroke Fields (south) and runs east to west between Nightingale Lane and the railway line (Figure 5.3). The avenue comprises a single row of mature horse chestnut trees interspersed with younger lime and red horse chestnut trees. The oldest cohort of these trees has a mean estimated age of 156 years (and so it is likely that this avenue was first planted in the 1860s).

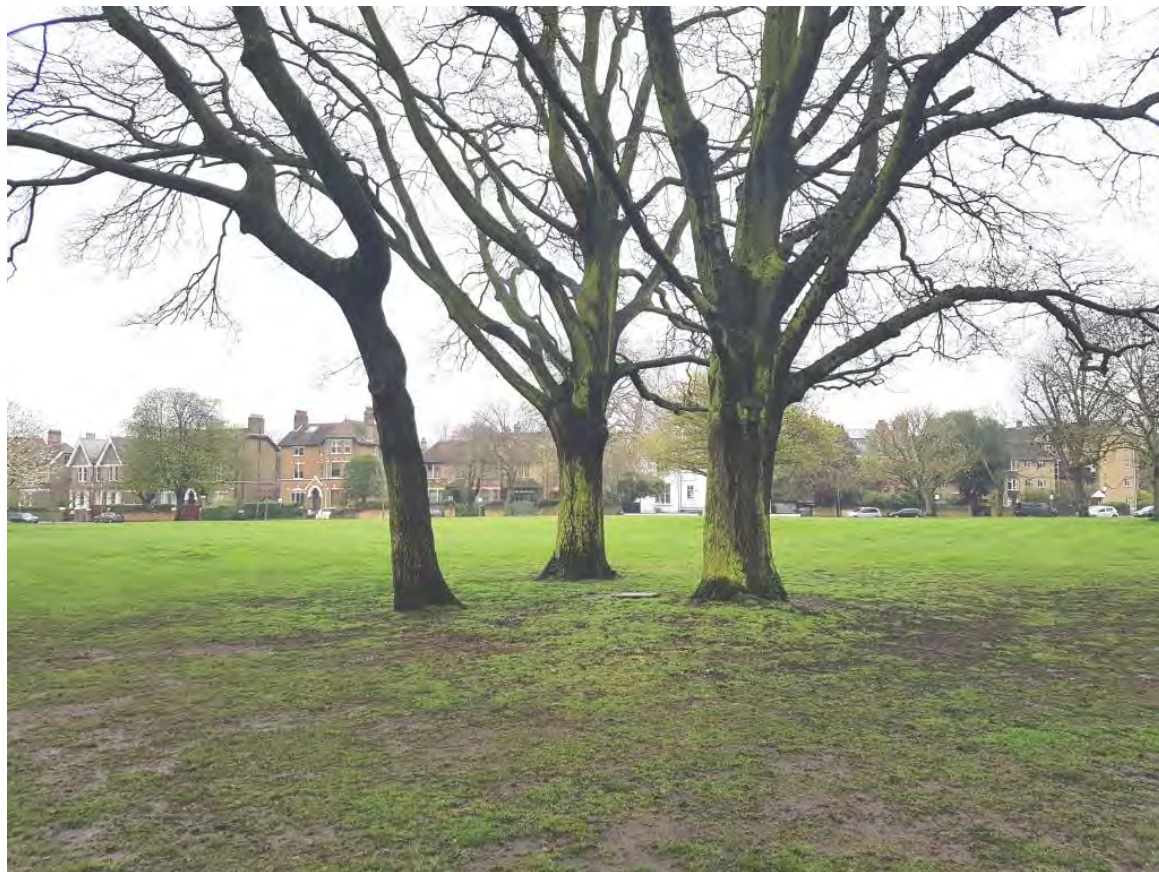
Figure 5.4 Planting trees in triangle formations is an unusual characteristic of the Common

- 5.21 An unusual feature at the Common is the planting of groups of three trees in triangle formation (Figure 5.4). This is clearly visible in the groups of London plane on the East Side and on both sides of Trinity Road at the northern end of the Common.

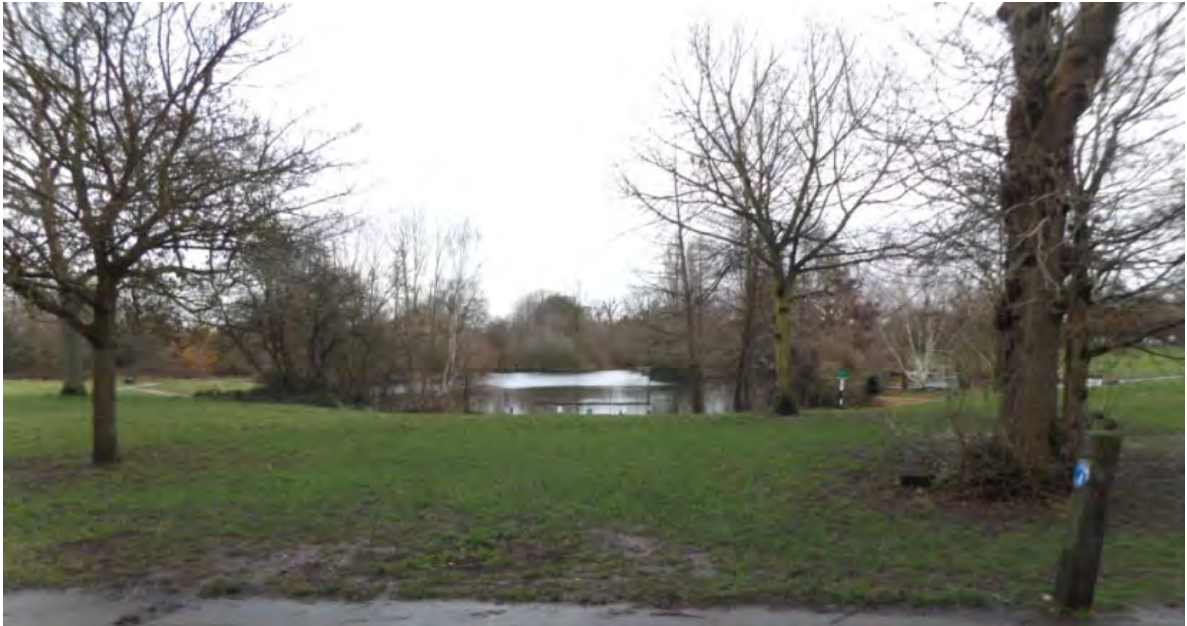
Figure 7.3 Fishing lake viewed from the east

- 7.17 The lake level is allowed to drop from its wet-weather level by up to 10" in drier periods before the Council tops the pond up using a mains feed. This typically takes place three or four times a year and involves lifting the water-level back up by about 5-6" which corresponds to a level just below the overflow crest. Each fill takes about a day to complete.
- 7.18 During particularly severe wet weather, the wildlife lake has been known to overflow at the northern end, allowing water to flow along the adjacent path to a low point towards the railway footbridge and down onto the railway cutting (Figure 7.5 overflowing water flows along path in background towards the left direction. Railway cutting is beyond the fence).

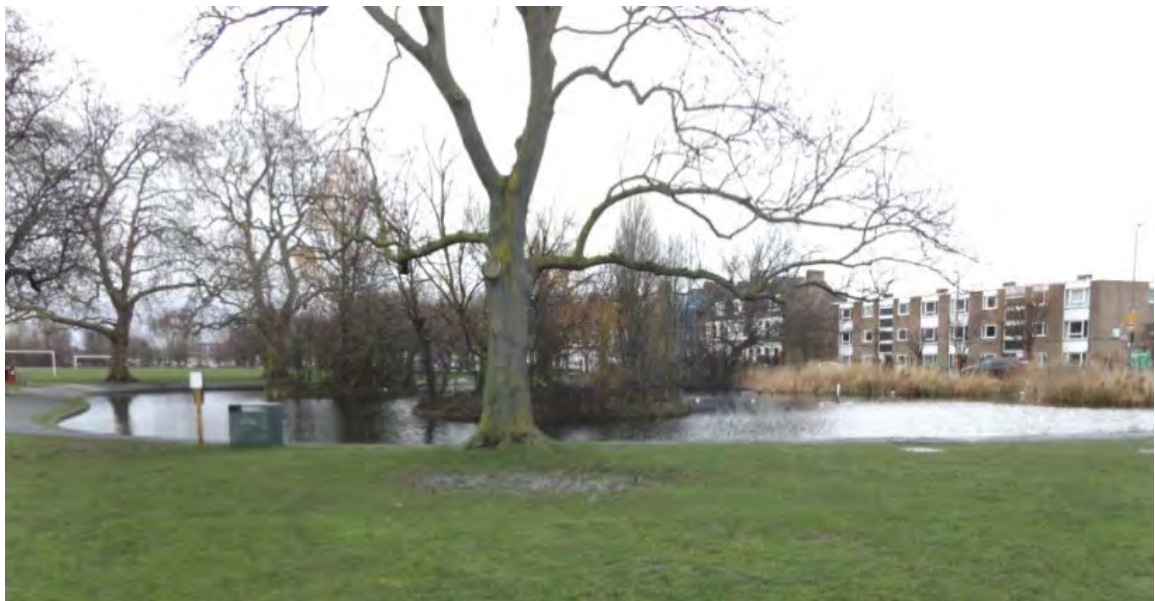
Figure 7.6 Three Island Pond

- 7.19 The Three Island Pond also has no apparent formal water feed, though there is an inlet believed to be from an old land-drain system serving some of the nearby pitches. The system's age is unknown and it is no longer reportedly effective. The pond is also believed to be affected by groundwater levels, although it has not known to overflow.

- 7.20 An aerator pump has been installed in Three Island Pond and runs continuously. Previous attempts to aerate the Pond (and the lakes) naturally using underwater vegetation have been

unsuccessful as it has been eaten by waterfowl. The Pond's water level drops in similar manner to that in the lakes in drier periods and requires occasional top-up from a mains feed.

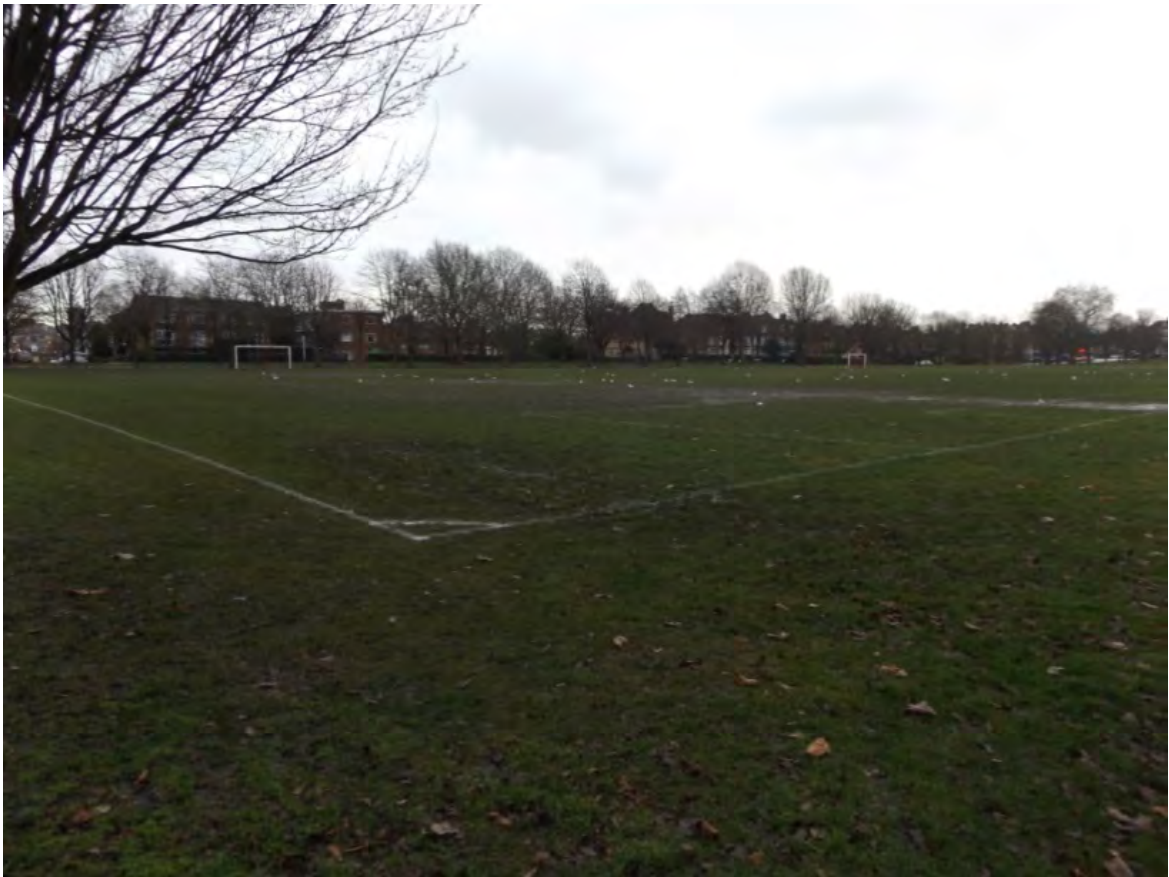
Figure 7.7 Bolingbroke Fields (southern section)

- 7.23 Two major sewers cross the Common, aligned broadly south to north and east to west.
- 7.24 The Bolingbroke Fields pitches are the main area of land-drainage problems on the Common, due to the need for maintaining usable playing surfaces on ground that, without improvement, is unsuitable for such intense use in wet weather. On average the pitches are deemed unusable for about four weekends every season, but this varies if the weather is drier or wetter than usual. Drainage works were undertaken on the pitches during 2018. The effectiveness of this work will be monitored and if they prove successful further works will be undertaken if necessary.

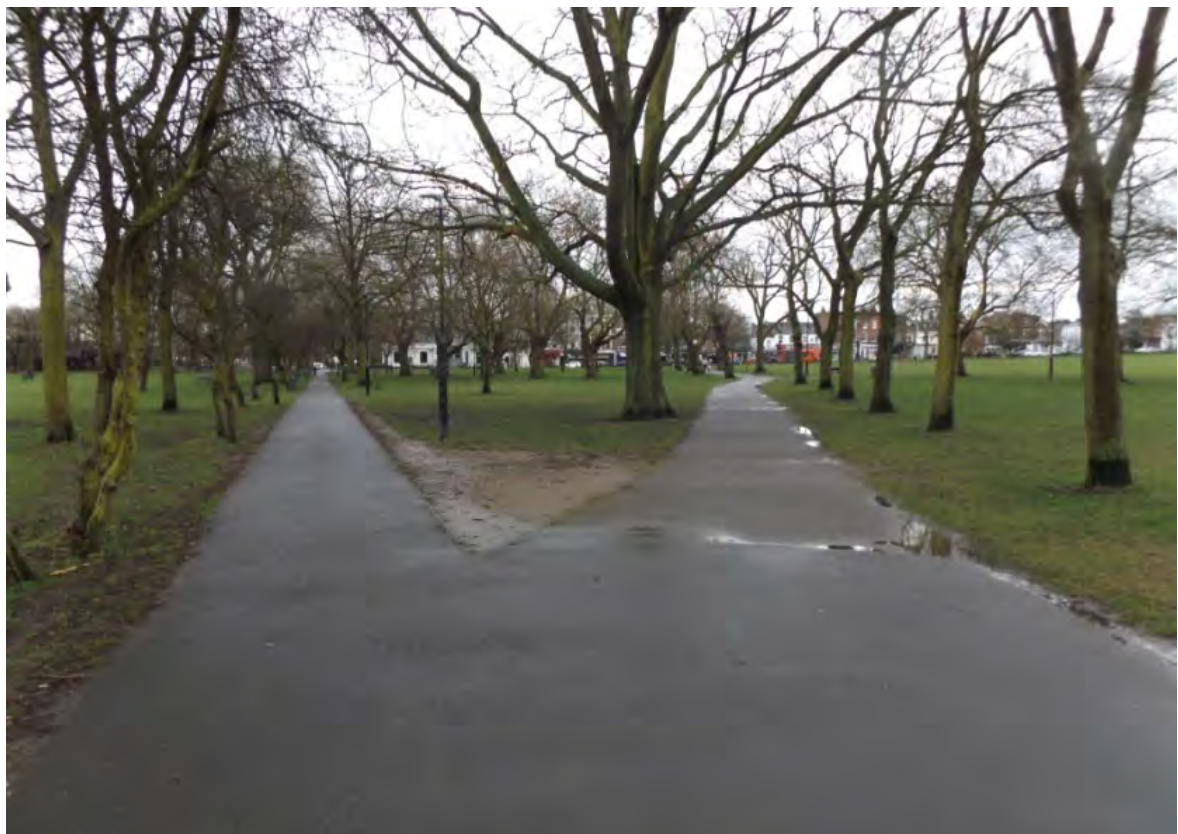
Figure 7.9 Footpaths near Bellevue Road showing typical marginal conditions

- 7.25 The margins to the various paths across the Common do not suffer greatly from run-off damage exacerbating soft ground.

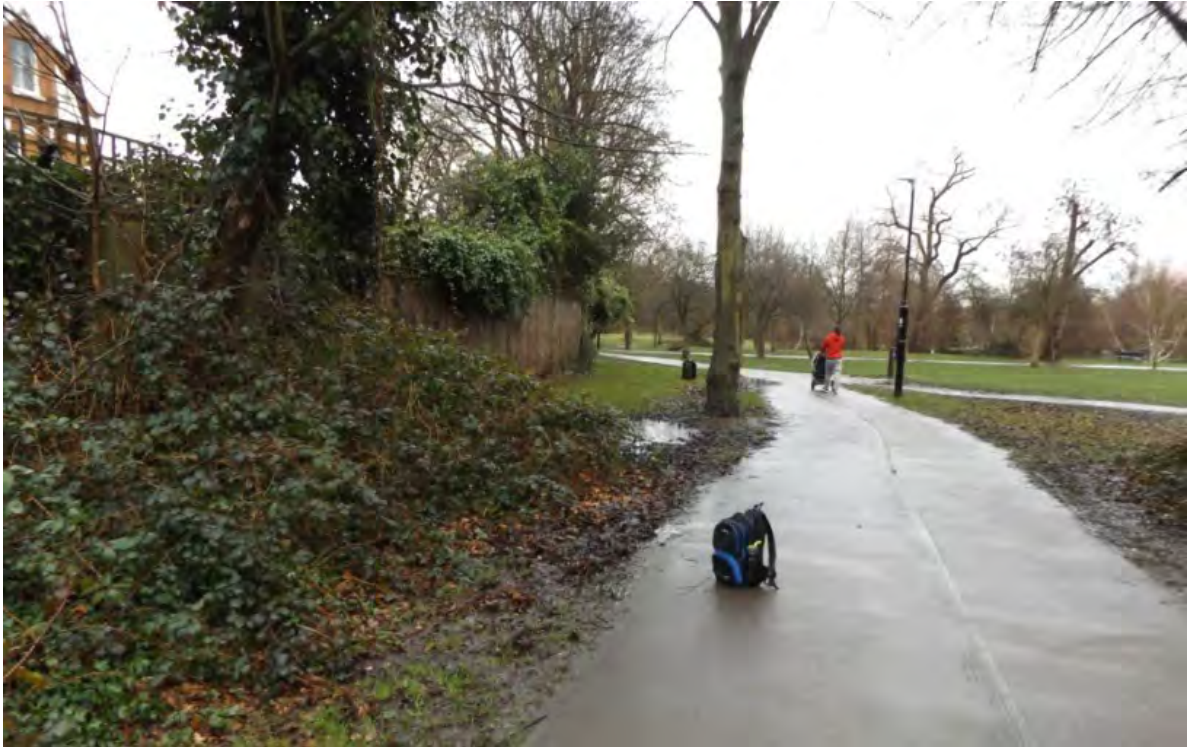
Figure 7.10 Location of waterlogged land

- 7.26 There is one location where marginal ponding and water-logging is a particular problem, to the point that it has generated occasional comments from local residents, beside a junction of paths behind housing at the corner of Routh Road and Baskerville Road. There is no obvious source of greater-than-usual run-off and it may simply be no more than the local path levels holding slightly more water back on the outer margin of the path surface that exacerbates waterlogging of the soil and/or a patch of soil that is locally less pervious.

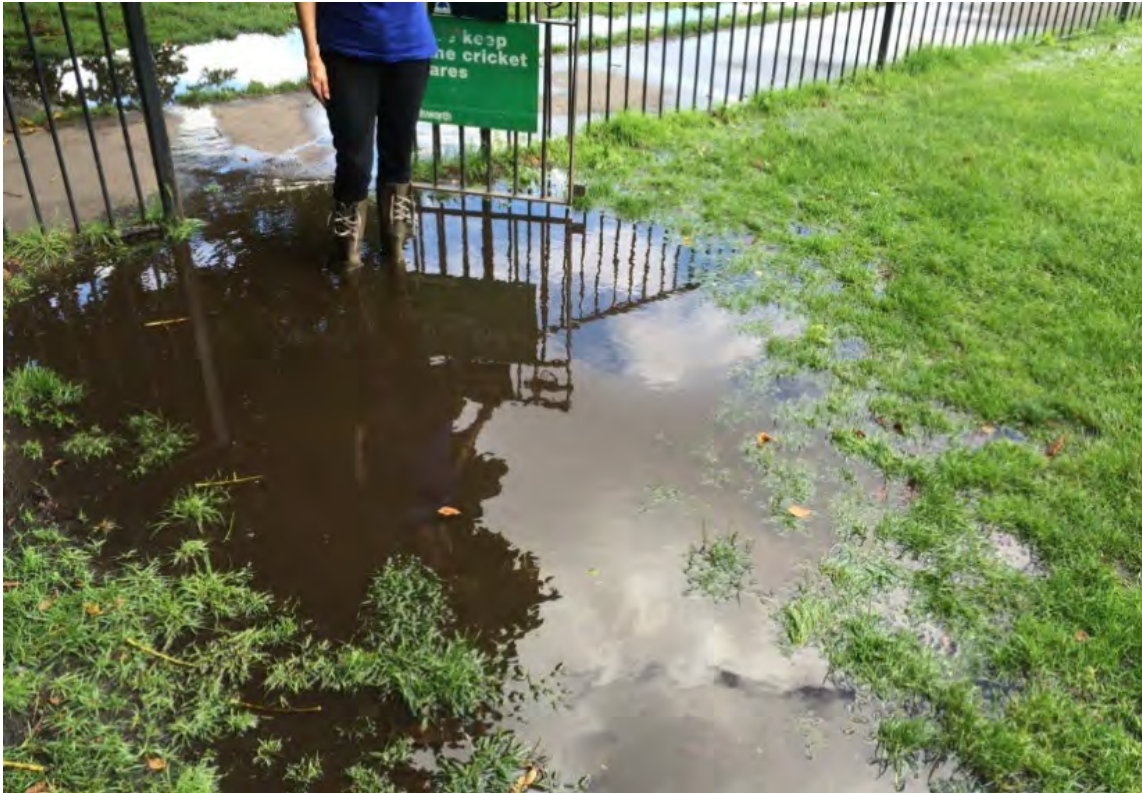
Figure 7.13 Puddling and surface flows on edge of cricket pitch, (MAC/FOWC)

- 7.27 Occasional local ponding or waterlogging has also been reported during the consultation process on areas adjoining the paths leading northwards from Bellevue Road and abutting Trinity Road on the south-western side of Bellevue Fields. The field south of the café and north of the lakes and the margins of the cricket-pitches field are also reported as being prone to waterlogging and/or suffering from high levels of informal use (e.g. personal trainers and their clients) during such conditions. Compaction is made worse by runners frequently jogging alongside the surfaced paths in several locations across the Common, as well as areas where groups gather such as outside the playground.

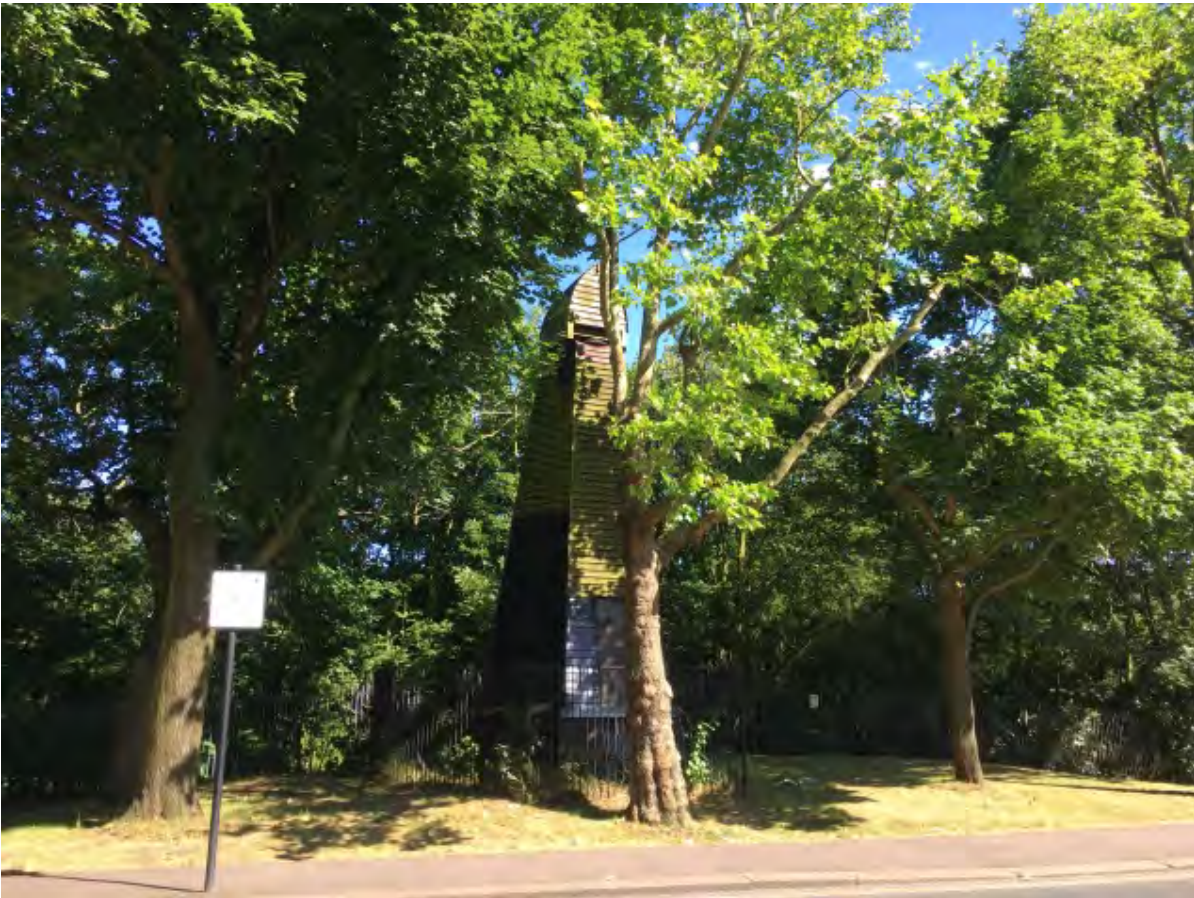
Largely obscured from the Common by surrounding vegetation and in poor condition. No interpretation to communicate its importance.

Looking east from Northside Field.

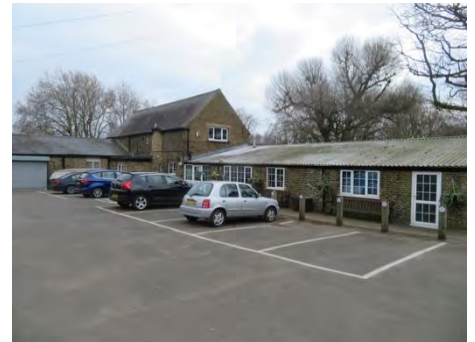
*Park offices from north-west*

All built on top of a brick boundary wall running along the south side of the farmyard. The wall matches other sections along the railway and is therefore presumed to date from about 1856. The western part is now laid out as single storey offices, much remodelled north wall, PVC windows and modern low pitched roof. The eastern part is of two storeys, brick with a slate roof. The upper storey extends over storage accessed from the east range.

**Condition:** Fair but many western areas are of insubstantial construction and eastern areas much altered.

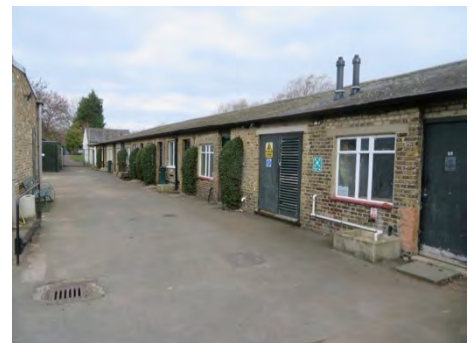
*East range from south*

Long single storey range abutting and built onto a brick wall along the east side of the farmyard. The wall matches other sections along the railway and is therefore presumed to date from about 1856. Slate roof on timber roof structure, including at least some original trusses. Now arranged as a series of changing rooms, a boiler house and store. Metal windows and metal clad timber doors.

The present buildings appear to match the footprint of those shown on the map of 1866.

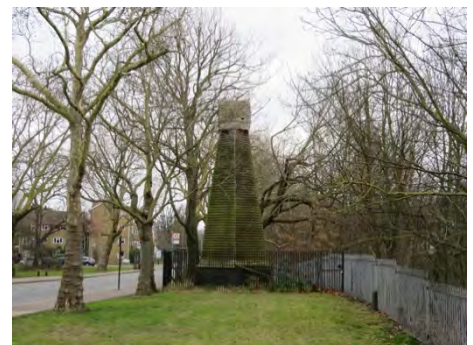
Significance: Of considerable significance as one of about eight surviving drainage smock mills.

*Smock mill from south-west*

Potential: Opportunities to improve setting and interpretation.

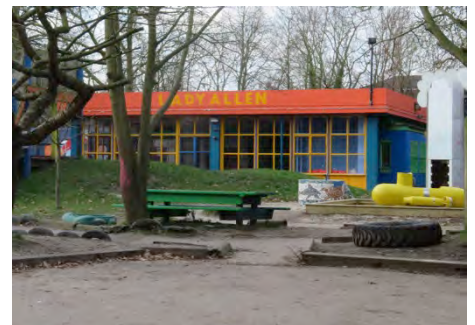
Potential: The building requires significant investment to place it in good order but could accommodate a range of possible uses within the existing primary structure.

*Lady Allen building exterior*

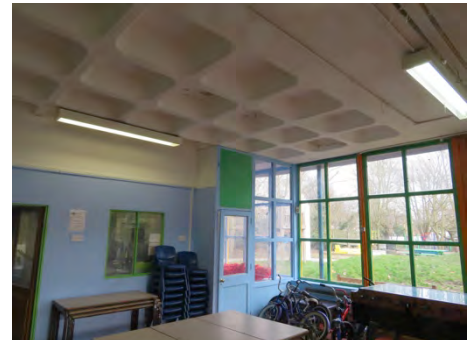
*Lady Allen building interior*
