April 2004

Wandsworth Park

Strategy Plan

Prepared for London Borough of Wandsworth
by Land Use Consultants

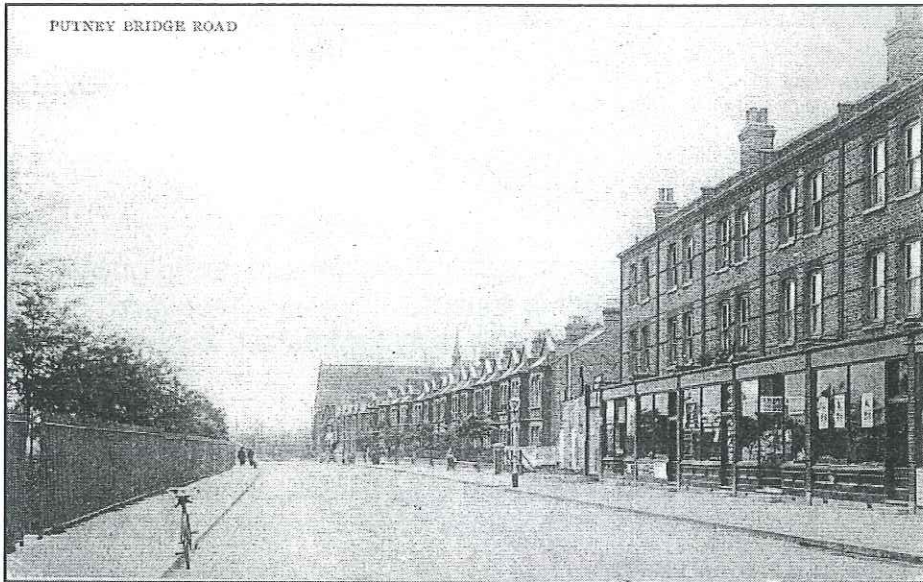
FIG. 8: View East along Putney Bridge Road. The park railings were removed as part of the war effort. Undated photograph

- 5.6.2 *Railings:* removal of existing mild steel fence on Putney Bridge Road and Northfields boundary (up to the Point Pleasant gate) and replacement with heritage style railings based on original 1903 design. The railings were much taller than the current utilitarian design and will make a positive improvement to the appearance of the park.

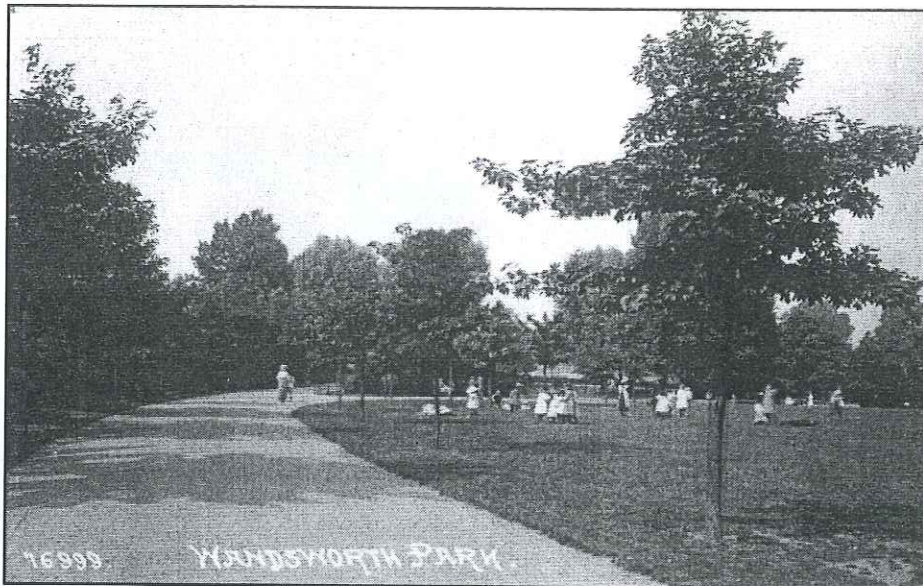
FIG. 11: View towards River Thames at western end of Park. Undated photograph

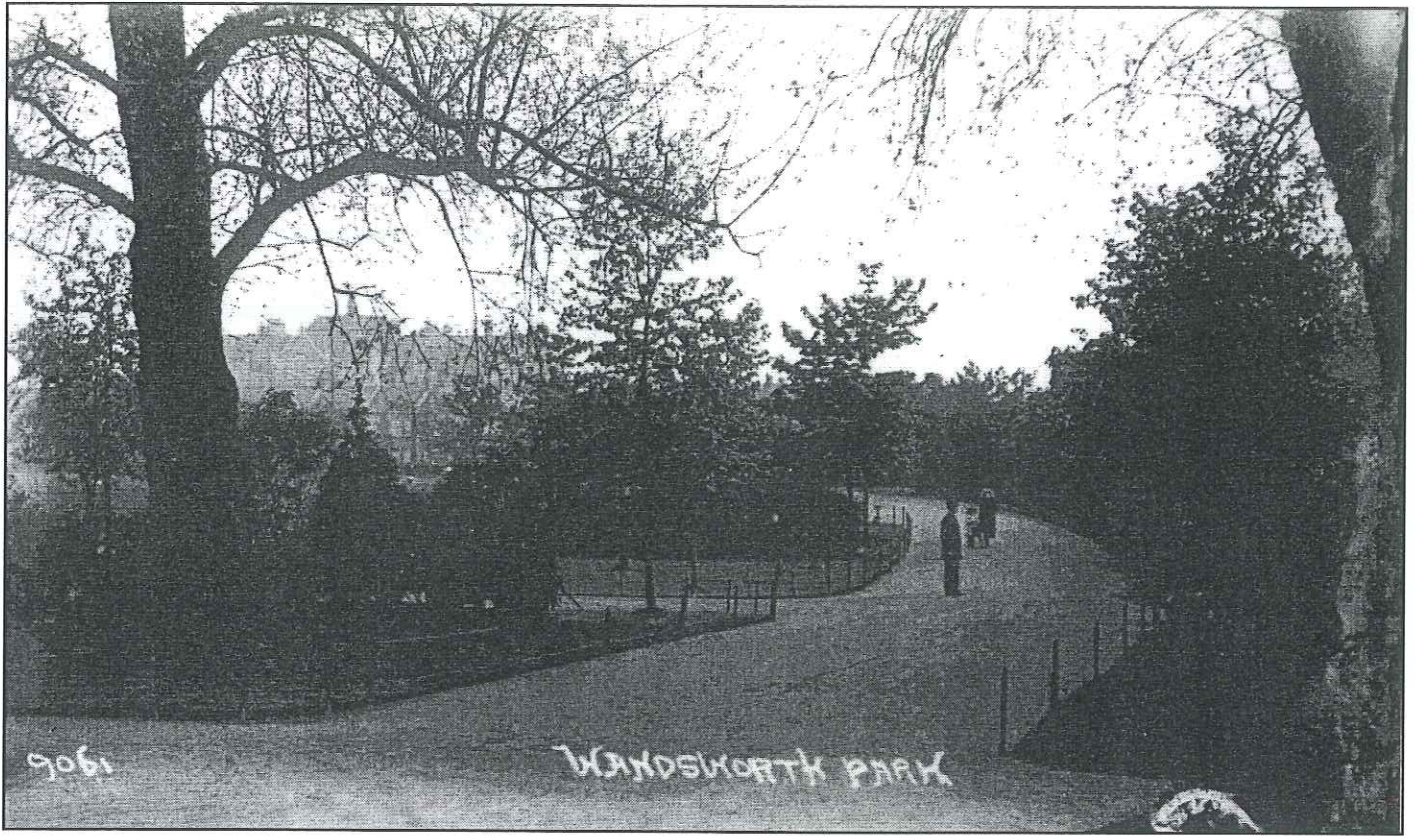
FIG. 14: View of both mature trees and more recently planted trees, in post and wire enclosed beds, near the current playground. Undated photograph

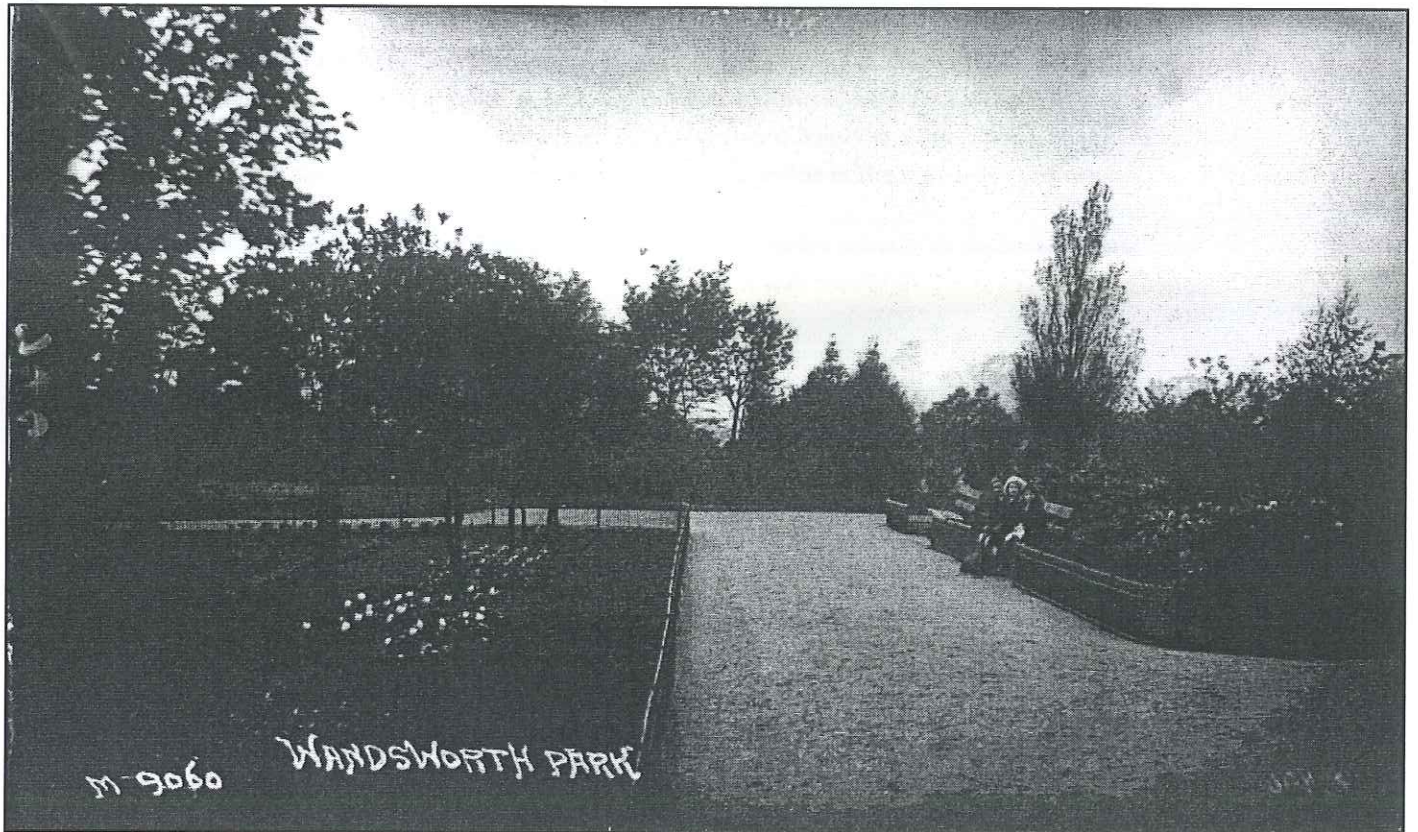
FIG. 15: View of the northern side of the decorative bedding area, with tulips planted beneath standard shrubs. Undated photograph

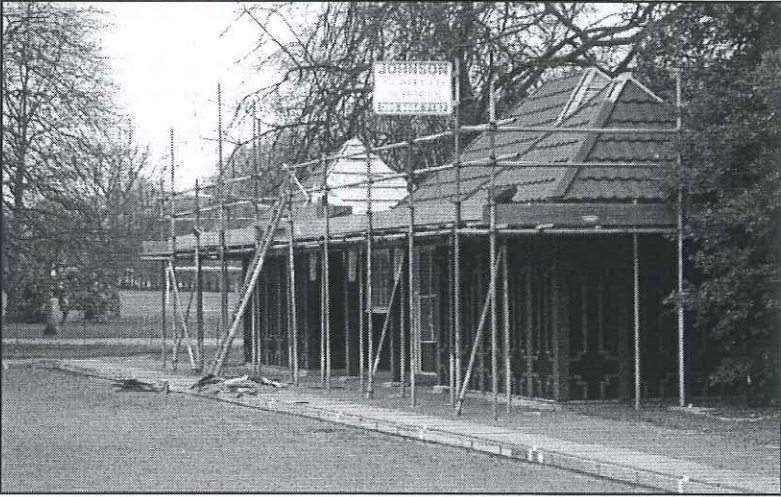
2. The public convenience building, before its demolition and replacement with the sports pavilion and change rooms. Sexby approved of the vernacular style of the 1910 built conveniences.

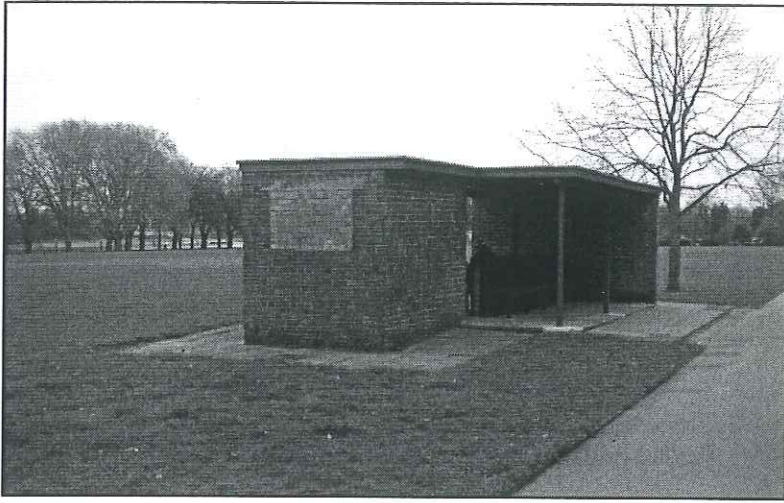
1. The south west shelter, built in 1955, is inappropriate to the park's character, in poor condition and is best removed.

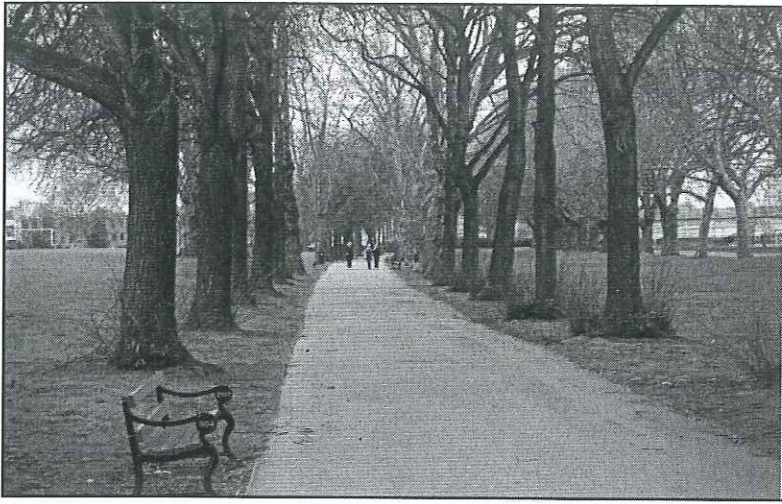
1. Avenue of Lime trees, *Tilia*, along the inner path running parallel with the Thames.

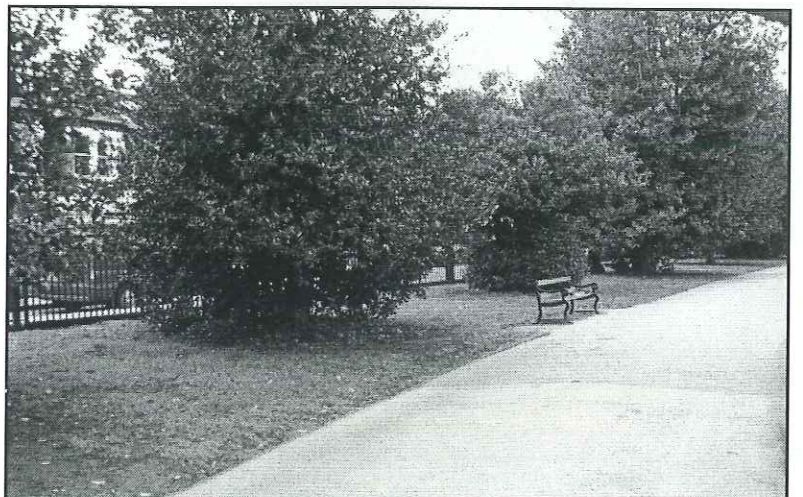
1. The multiple gates of the south west entrance onto Putney Bridge Road and the functional design of the space, offer little invitation to enter.

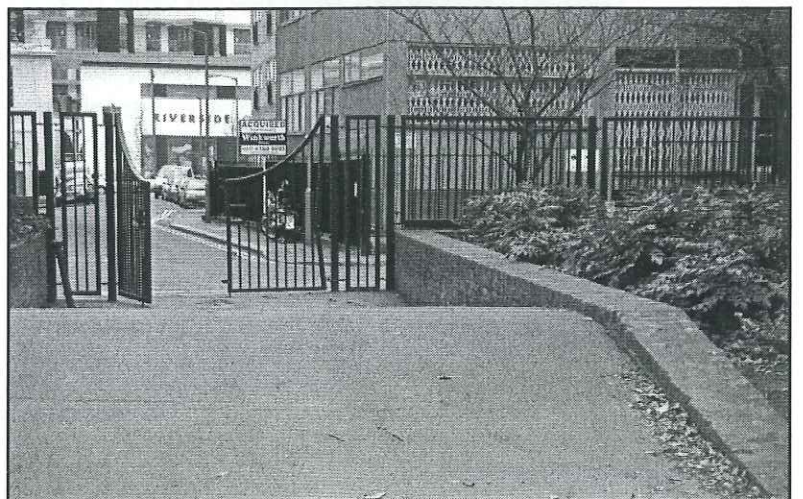
6. The Point Pleasant gate and flood defence barrier.

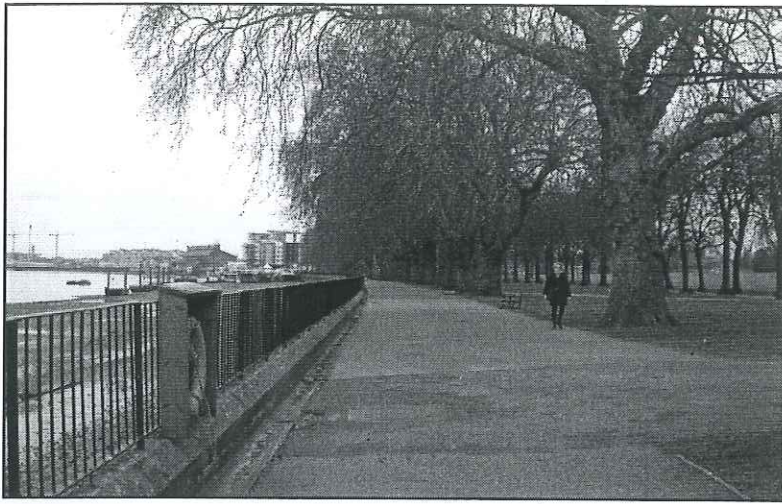
1. The existing path and railings do little to celebrate the riverside location and the excellent views which visitors can enjoy. It is proposed to share use of the 6m wide path with cyclists.

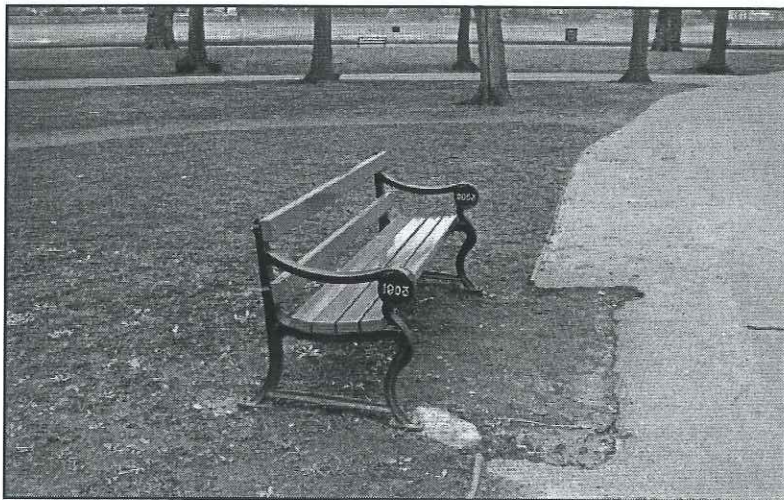
2. Twenty five centenary commemorative benches have been installed where old benches stood, however more are needed. This example requires tarmac surface repair to link it to the path.

- 5.6.9 *Install extra benches and litter bins*: throughout the site as required, but particularly along the path adjacent to Putney Bridge Road, where there is a lack of furniture and allow for tarmac repairs to the surrounding area after installation.

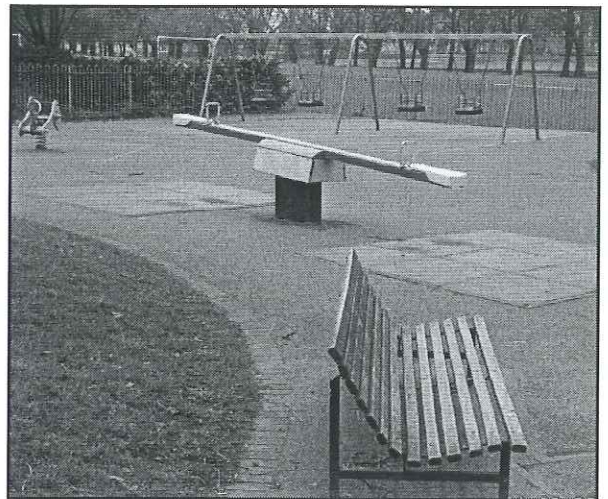
3. An older bench remains in the playground and should be replaced with several benches to match the centenary bench design.

- 5.6.6 *Play Area*: upgrade surfacing so that all equipment is linked with either bitumen macadam or safety surfacing. Replace the existing seat with one or more which match the centenary benches.

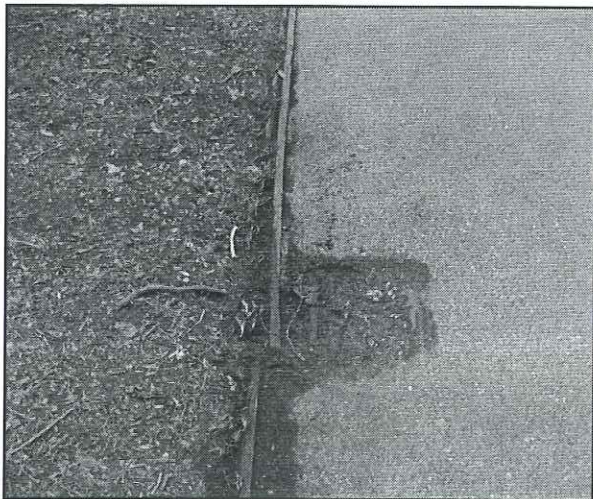
4. Some tarmac repairs are needed, combined with more frequent maintenance of gully drains which quickly become blocked with soil.

- 5.6.7 *Tennis courts*: replace mesh fencing and allow for resurfacing and line marking when required.
- 5.6.8 *Path resurfacing*: where tarmac paths have been damaged, by tree roots etc, or the surface has deteriorated, localised repairs can be made and a new wearing course applied to the existing base.

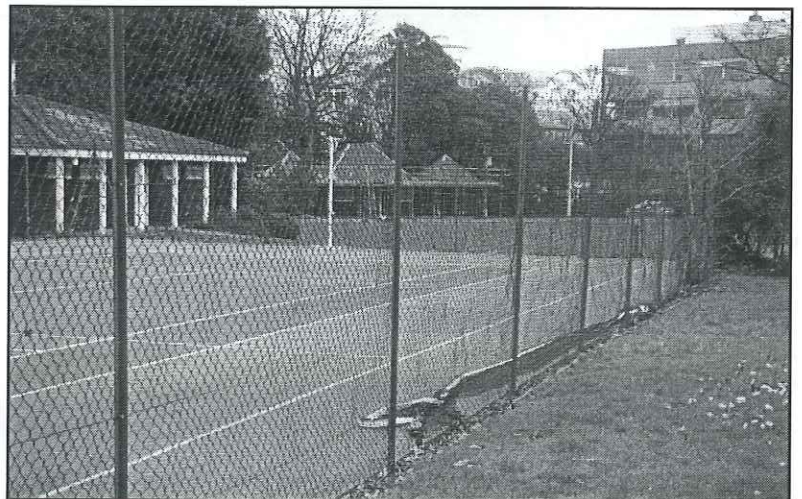
5. The tennis court mesh fence is only supported by steel angle posts and requires retensioning on a regular basis.

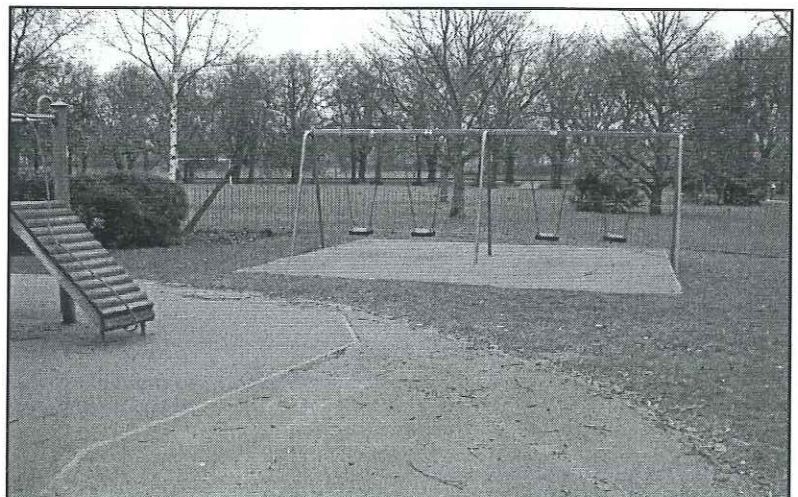
6. Some surfacing work is required in the playground, particularly to ensure all equipment is connected by either tarmac or safety surfacing.

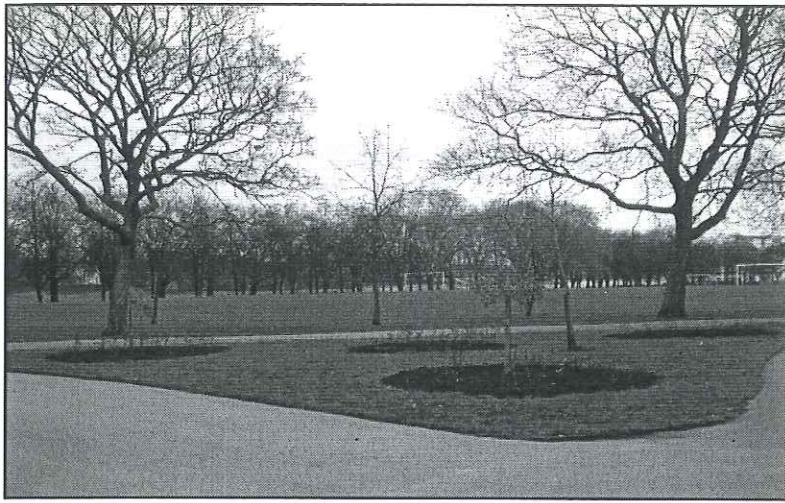
1. The rose beds at the south west entrance would originally have been planted with a more diverse range of plants, surrounded by hoop top edging.
2. The decorative bedding area, designed by Sexby as the horticultural showpiece, is at the main south east entrance. Whilst the edging has been replaced recently the low level planting could be much more interesting.
3. One of the original shrubberies in the south east area, which are now over mature and require selective thinning and replanting.

- 5.5.4 *South-west corner planting beds:* replace rose beds with redesigned layout including permanent shrubs, lower-maintenance types of perennials and some annual bedding, to improve visual interest and to more closely match the original design intention.

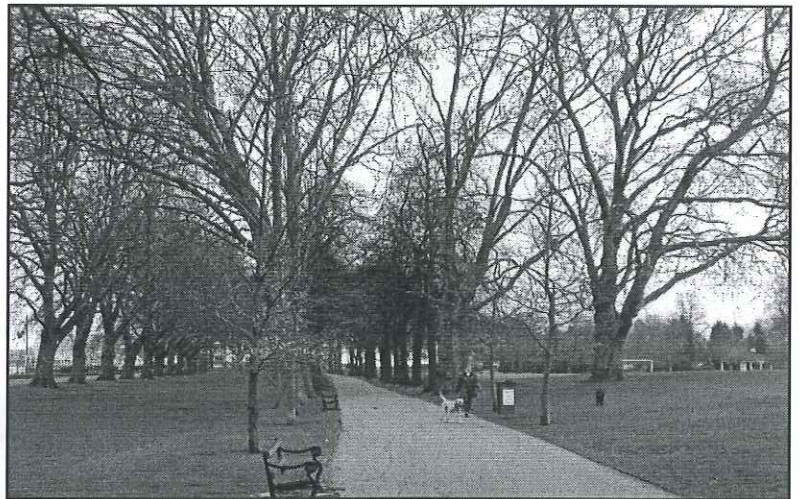
4. Possible improvements to the Putney Bridge Road frontage are the establishment of a row of large shade trees to replace the original False Acacias, underplanting the area with groundcovers and installing hoop top edging along the path.

- 5.6.4 *Putney Bridge Road frontage*: after the replacement of the 1903 style railings along Putney Bridge Road, the adjoining patchy grass strip between the railings and path could be replaced with groundcover plants and hoop top edging, to emulate the original design of this area. As the ground is now shaded by numerous trees and the Holly bushes, it would be difficult to establish taller growing plants.

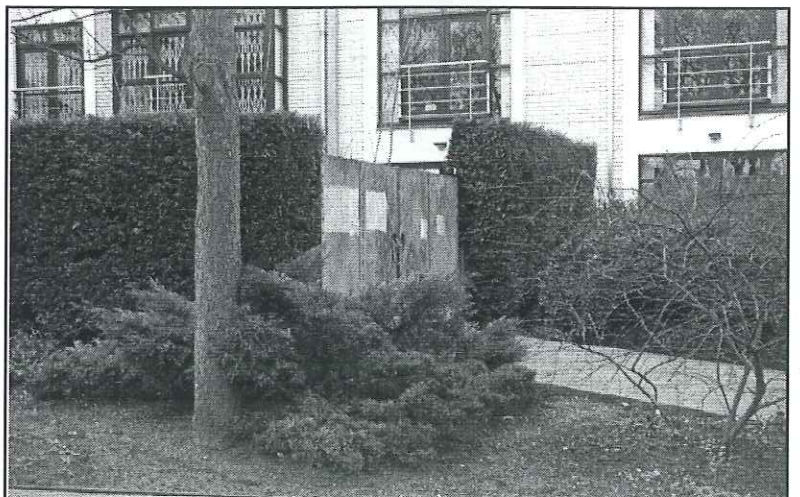
6. When the storage yard at the park's western end is removed, the surrounding planting needs to be reworked, with removal of the yew hedge.

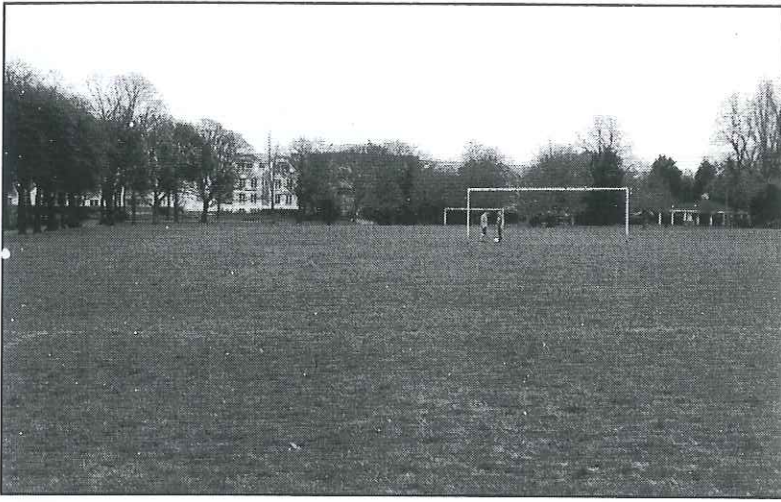
1. The three football pitches and two cricket wickets are well used but mainly at weekends.
2. The popular children's play area is the most significant addition to Sexby's 1903 design.
3. Dog walking is one of the primary activities within the park. 90% of the park is a 'poop scoop area' but how well used are the bins provided.

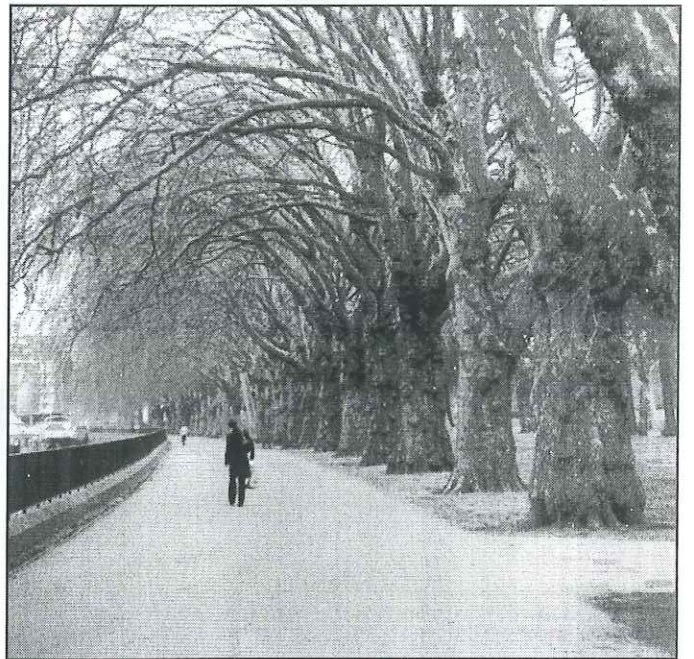
4. Local school children play in the park at lunchtime.
5. The Thames Side Walk offers excellent views and forms part of the 213 mile Thames Path National Trail.
6. Although current byelaws ban cycling in the park, people frequently ride through. It is anticipated that the proposed shared cyclepath along the riverside would be very well used.
